AAA Home Inspections

Property Inspection Report

4808 Pepperwood Way, San Jose CA, 95124 Inspection prepared for: Karin Dillin & Natalie Kraten Agent: Stacy Seymour - Coldwell Banker

Inspection Date: 6/11/2011 Time: 11:00

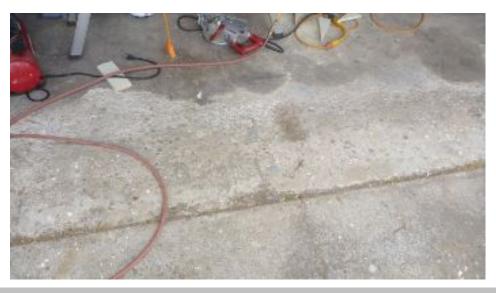
Spalling noted at front of garage, recommend repairing

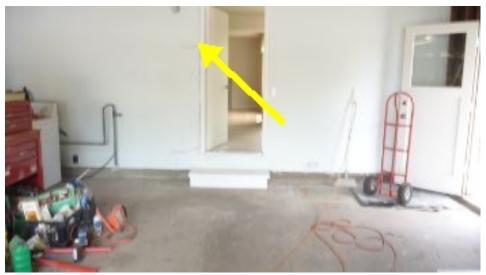
• There is no self-closing device on the door from the house leading to the garage. It is strongly recommended that one be installed in order to protect the residence against garage originated fires.

Door going into house needs self closing hinges

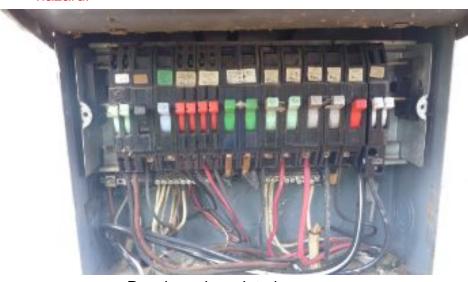
There is a Zinsco service panel present. Zinsco components are prone to problems that can lead to failures, lack of proper protection of circuits and other serious issues, including fire and electrocution. We cannot definitively call this panel defective, but recommend, for your peace of mind, to consult a qualified electrical contractor to get their opinion on this matter. You can learn more about this issue at http://www.inspect-ny.com/electric/zinsco.htm
Panel cover missing, exposing live electrical wires as an electrocution hazard.

Panel needs an interior cover

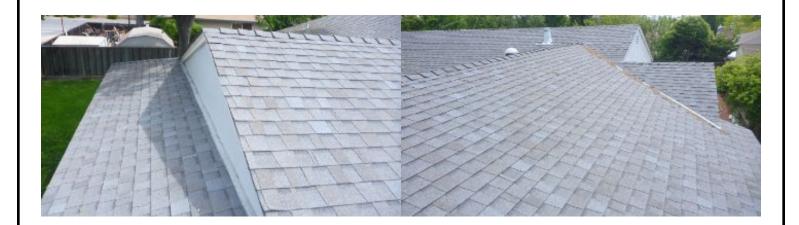
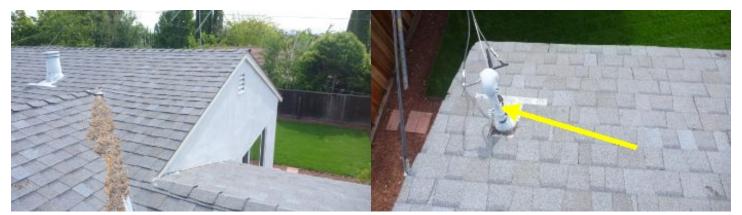
Large amounts of organic debris noted

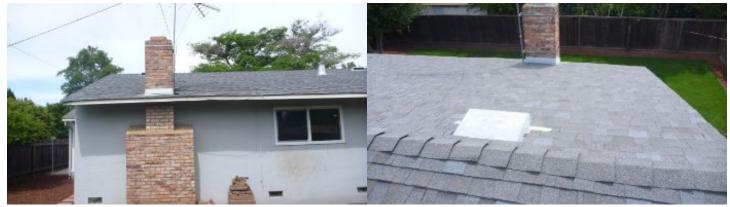
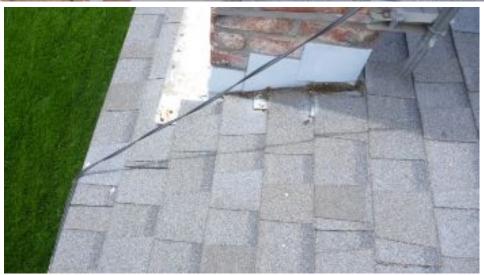
• Flashing at gable above garage and around chimney are lifting. Recommend fastening the flashing to the roof deck and caulking around the flashings

Chimney flashing

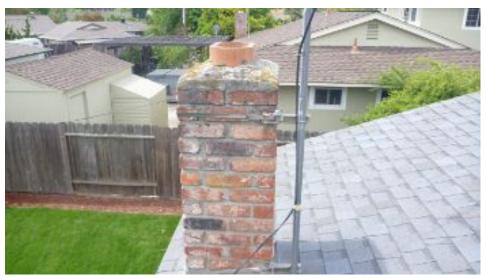
Spark arrestor should be installed

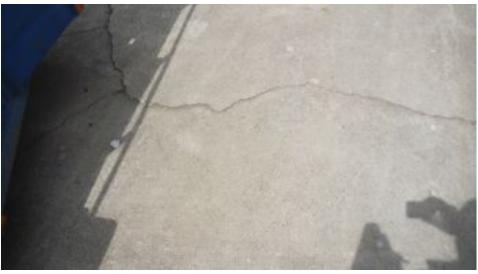
Heavy cracking noted at driveway and some spalling at front of garage and on the inside of the garage

Common cracking
