AAA Home Inspections

Property Inspection Report

4808 Pepperwood Way, San Jose CA, 95124 Inspection prepared for: Karin Dillin & Natalie Kraten Agent: Stacy Seymour - Coldwell Banker

Inspection Date: 6/11/2011 Time: 11:00

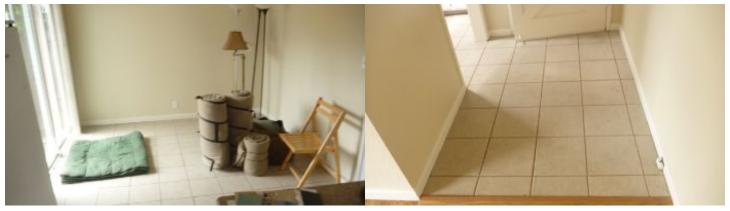
Dining area

Tile entry noted

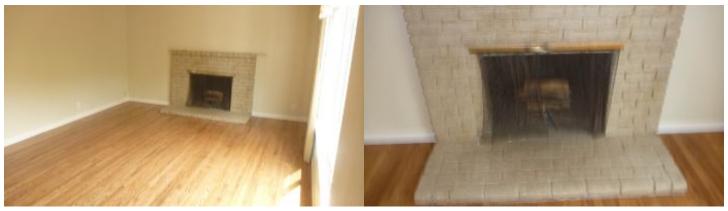
Fireplace located in living room

Hardwood floors noted

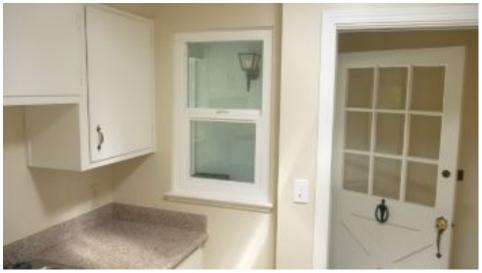
Upper cabinets noted

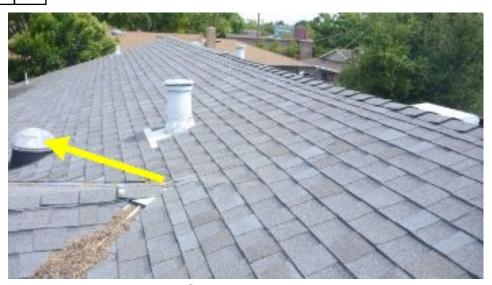
Sun tunnel noted

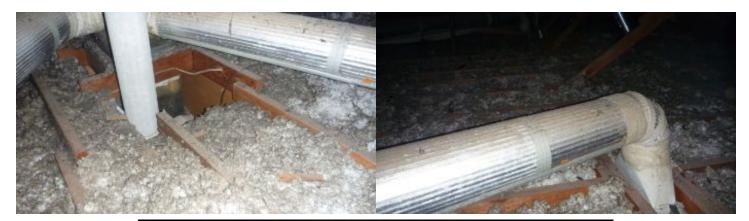
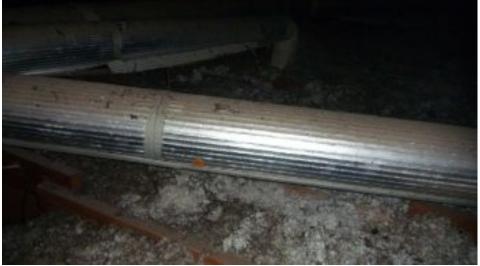
- functional
- Possible asbestos materials observed. The materials appeared to be in serviceable condition at the time of inspection. Asbestos materials are considered safe by the EPA if they are not disturbed, torn, ripped, or damaged. No torn, ripped, or damaged materials were observed. If client has any concerns regarding asbestos materials, an asbestos testing lab should be consulted for further review to ensure safety.

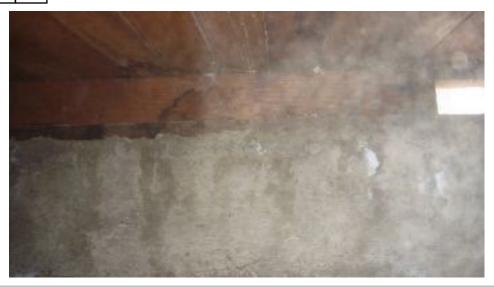
normal settlement

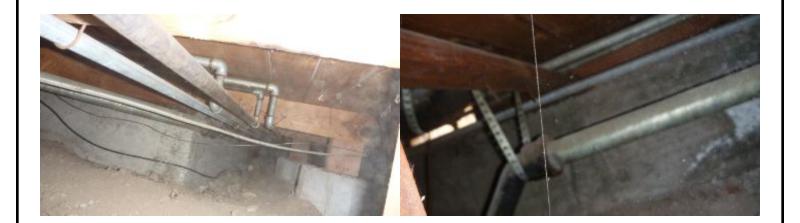
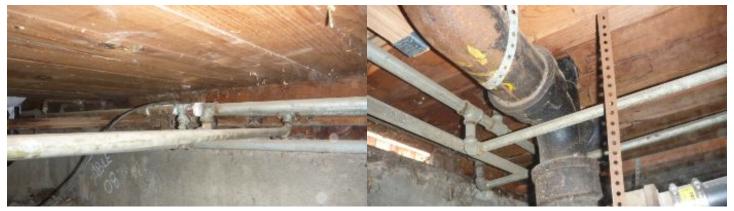
Galvanized pipes
